**Flood Control Project Maintenance
Levee Inspections**

Fall 2016 Levee Maintenance Deficiency Summary Report

Levee District No. 0001 (Glenn County)

Waterway			Bank	Unit Miles
Unit No. 01 Sacramento River			Right	12.23
	Spring (March - May)	Summer (June - August)	(September - November) Fall	Winter (December - February)
Unit Maintenance Rating (Fall Only)			M	
Date of Inspection	4/15/2016 - 4/15/2016		9/16/2016 - 9/16/2016	
DWR Inspector	Keith Millard		Tariq Chechi	
Accompanied By	Bill Carriere		Bill Carriere LD1G

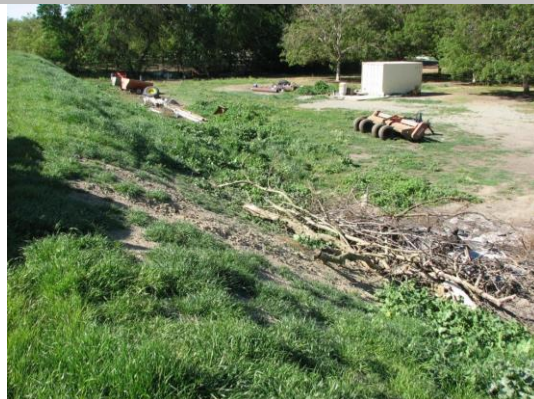
Photo 1 of 1 : FA_2016_LD0001G_432_73_20160823_00035.jpg

View of the prunings pile and ag equipment at the landside toe.

LM Start	0.05	Rating **	M	Issue No.	40
LM End	0.05	Issue Type +	En	Location *	LS
Category	Earthen Levee			GPS Latitude/Longitude	
				Start	End
Item	Encroachments			39.477833 °	39.477833 °
				-122.017484 °	-122.017484 °
DWR ID	DWR_LD0001G_01_s_2016_40				
Comment Code					
PR : Prunings					
Inspector Comment					
Remove prunings at LS toe.

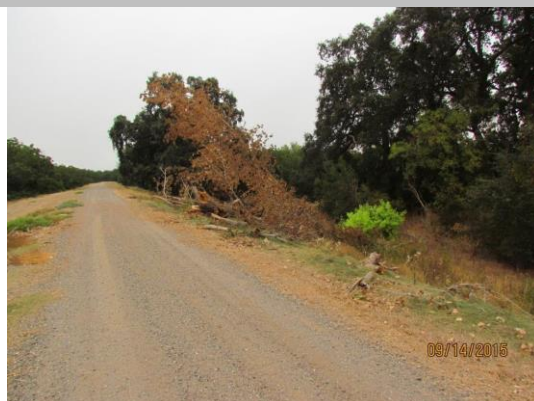
Photo 1 of 2 : FA_2016_LD0001G_432_41_20160823_00012.jpg

View of the tree on the waterside slope.

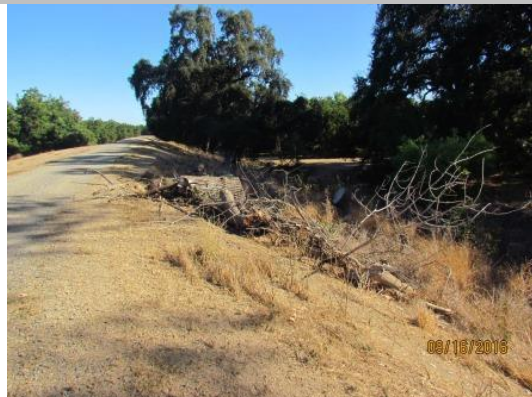
Photo 2 of 2 : FA_2016_LD0001G_432_41_20160922_00092.jpg

View of the fallen tree on the waterside slope looking upstream.

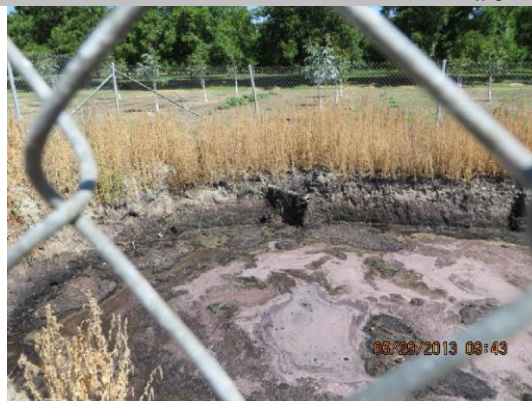
Photo 1 of 2 : UCIP_FA_2016_14324_23564.jpg

LM Start	0.77	Rating **	M	Issue No.	402
LM End	0.77	Issue Type +	En	Location *	WS
Category	Supplemental			GPS Latitude/Longitude	
				Start	End
Item	DWR UCIP Field Study			39.487806 °	39.487806 °
				-122.019414 °	-122.019414 °
DWR ID					
Comment Code					
Inspector Comment					
FS_ID:14324 DS_ID:22893 EP_NO: 11782 Repair Type: Non-Urgent Crossing Status: Found UCIP Comments: 5/29/2013 - Siphon breaker missing from WS shoulder (DWR UCIP - W. Wylie) FIELD_STRUCT_DESC: 3-inch galvanized steel pipe through levee, 2 feet below the crown. There is a hose bib style siphon breaker on the waterside (WS) shoulder. A pipe runs from the concrete sump next to the barn on the landside (LS) to a cesspool off of the WS toe (Permit No. 11782, 1977 - Carriere Brothers). [Additional Reference(s): DWR Levee Logs, 1992 FS Date: 5/29/2013

3-inch pipe at cesspool off WS toe.

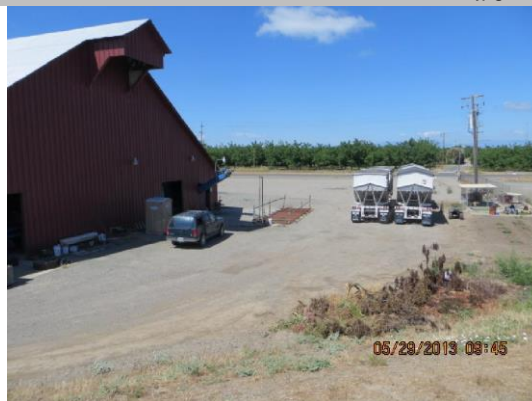
Photo 2 of 2 : UCIP_FA_2016_14324_23563.jpg

LM Start	0.77	Rating **	M	Issue No.	402 (cont)	
LM End	0.77	Issue Type +	En	Location *	WS	
Category	Supplemental			GPS Latitude/Longitude		
				Start		End
Item	DWR UCIP Field Study			39.487806 °	39.487806 °	
				-122.019414 °	-122.019414 °	
DWR ID						
Comment Code						
Inspector Comment						
FS_ID:14324						
DS_ID:22893						
EP_NO: 11782						
Repair Type: Non-Urgent						
Crossing Status: Found						
UCIP Comments: 5/29/2013 - Siphon breaker missing from WS shoulder (DWR UCIP - W. Wylie)						
FIELD_STRUCT_DESC: 3-inch galvanized steel pipe through levee, 2 feet below the crown. There is a hose bib style siphon breaker on the waterside (WS) shoulder. A pipe runs from the concrete sump next to the barn on the landside (LS) to a cesspool off of the WS toe (Permit No. 11782, 1977 - Carriere Brothers). [Additional Reference(s): DWR Levee Logs, 1992						
FS Date: 5/29/2013

Concrete sump next to barn off LS toe.

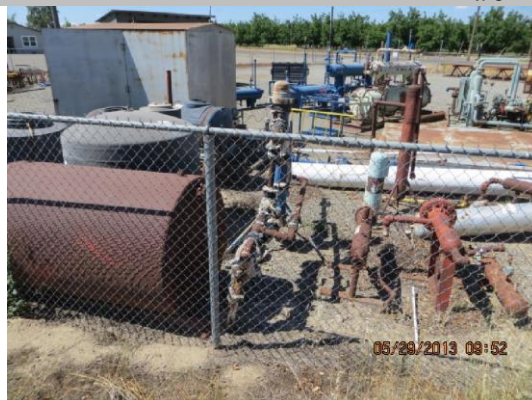
Photo 1 of 2 : UCIP_FA_2016_14325_23568.jpg

LM Start	0.80	Rating **	M	Issue No.	403
LM End	0.80	Issue Type +	En	Location *	WS
Category	Supplemental			GPS Latitude/Longitude	
				Start	End
Item	DWR UCIP Field Study			39.488160 °	39.488160 °
				-122.019888 °	-122.019888 °
DWR ID					
Comment Code					
Inspector Comment					
FS_ID:14325 DS_ID:22894 EP_NO: 1837 Repair Type: Non-Urgent Crossing Status: Indicator Found UCIP Comments: 5/29/2013 - Gasline appears abandoned, need to verify abandonment or mark actual pipe location. (DWR UCIP - W. Wylie) FIELD_STRUCT_DESC: 3-inch gas line of an unknown material through the levee, 2 feet below the crown (Permit No. 1837, 1959 - Sunray Oil Corporation). Fenced in pumping plant area next to levee with appurtances. [Additional Reference(s): DWR Levee Logs, 1992]. FS Date: 5/29/2013

Gas pumping plant and appurtances.

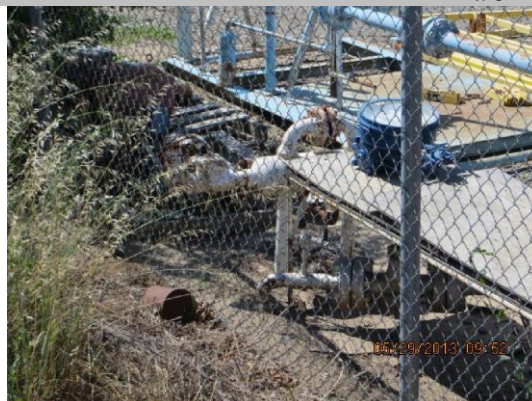
Photo 2 of 2 : UCIP_FA_2016_14325_23567.jpg

LM Start	0.80	Rating **	M	Issue No.	403 (cont)	
LM End	0.80	Issue Type +	En	Location *	WS	
Category	Supplemental			GPS Latitude/Longitude		
				Start		End
Item	DWR UCIP Field Study			39.488160 °		39.488160 °
				-122.019888 °		-122.019888 °
DWR ID						
Comment Code						
Inspector Comment						
FS_ID:14325 DS_ID:22894 EP_NO: 1837 Repair Type: Non-Urgent Crossing Status: Indicator Found UCIP Comments: 5/29/2013 - Gasline appears abandoned, need to verify abandonment or mark actual pipe location. (DWR UCIP - W. Wylie) FIELD_STRUCT_DESC: 3-inch gas line of an unknown material through the levee, 2 feet below the crown (Permit No. 1837, 1959 - Sunray Oil Corporation). Fenced in pumping plant area next to levee with appurtances. [Additional Reference(s): DWR Levee Logs, 1992]. FS Date: 5/29/2013

Possible pipe at crossing, LS toe.

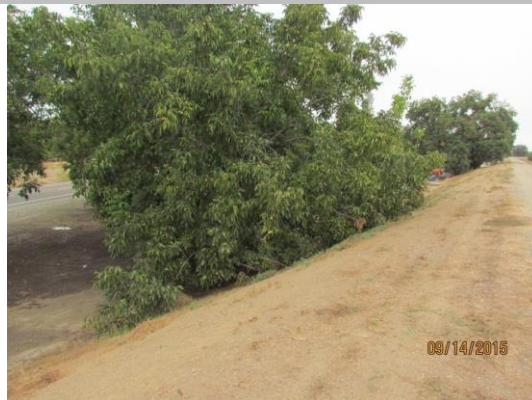
Photo 1 of 1 : FA_2016_LD0001G_432_43_20160823_00013.jpg

LM Start	1.01	Rating **	M	Issue No.	43
LM End	1.01	Issue Type +	Ma	Location *	WS
Category	Earthen Levee			GPS Latitude/Longitude	
				Start	End
Item	Trim / Thin Trees			39.490963 °	39.490963 °
				-122.020510 °	-122.020510 °
DWR ID	DWR_LD0001G_01_f_2016_43				
Comment Code					
T1 : Trim trees to at least five feet above ground level.					
Inspector Comment

View of the tree limbs on the landside slope.

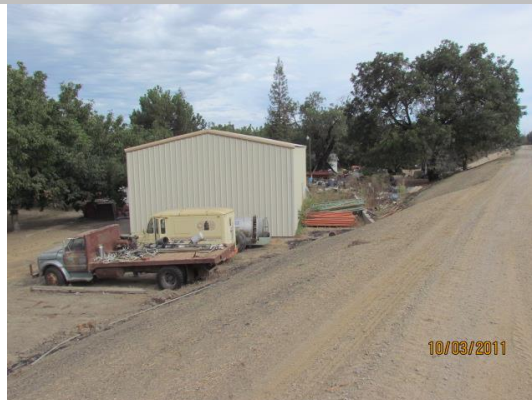
Photo 1 of 1 : FA_2016_LD0001G_432_74_20160823_00036.jpg

View of vehicles & equipment along the L/S toe.

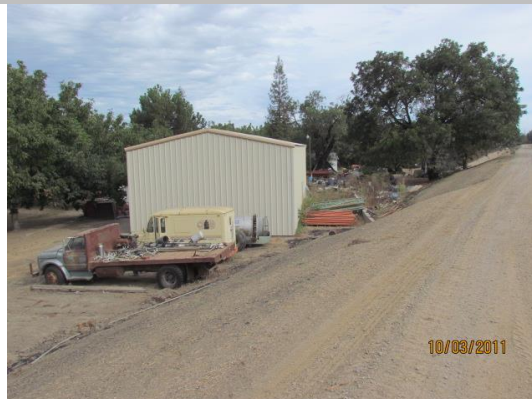
Photo 1 of 1 : FA_2016_LD0001G_432_4_20160823_00002.jpg

View of unpermitted building L/S toe.

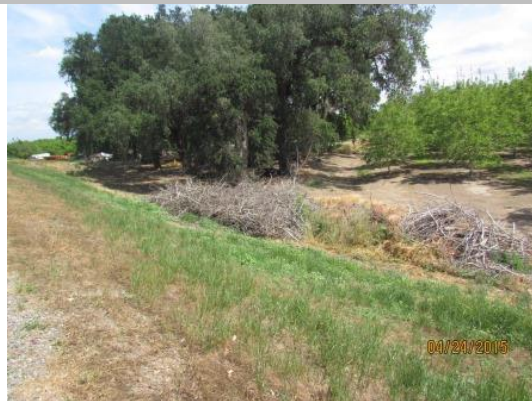
Photo 1 of 1 : FA_2016_LD0001G_432_58_20160823_00026.jpg

View of the prunings along the waterside toe.

LM Start	1.15	Rating **	A/W	Issue No.	58
LM End	1.15	Issue Type +	En	Location *	WS
Category	Earthen Levee			GPS Latitude/Longitude	
				Start	End
Item	Encroachments			39.492788 °	39.492788 °
				-122.019437 °	-122.019437 °
DWR ID	DWR_LD0001G_01_s_2015_58				
Comment Code					
PR : Prunings					
Inspector Comment					
Remove prunings at LS toe.

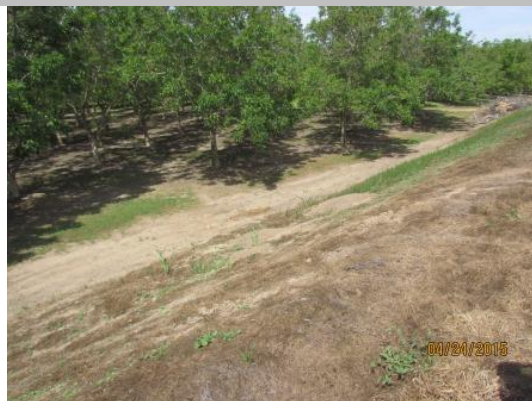
Photo 1 of 2 : FA_2016_LD0001G_432_59_20160823_00027.jpg

View of the rodent holes along the landside slope.

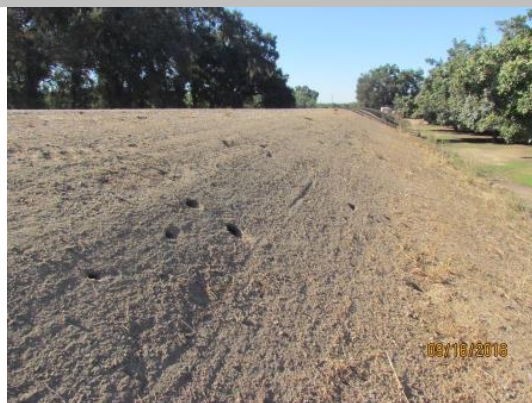
Photo 2 of 2 : FA_2016_LD0001G_432_59_20160922_00094.jpg

View of the rodent holes along the landside slope.

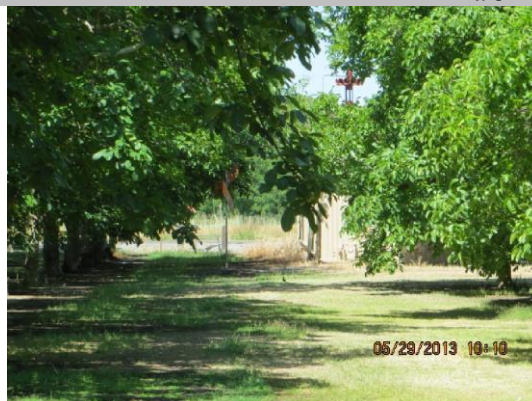
Photo 1 of 1 : UCIP_FA_2016_14327_23569.jpg

LM Start	1.25	Rating **	M	Issue No.	405
LM End	1.25	Issue Type +	En	Location *	LS
Category	Supplemental			GPS Latitude/Longitude	
				Start	End
Item	DWR UCIP Field Study			39.493977°	39.493977°
				-122.018380°	-122.018380°
DWR ID					
Comment Code					
Inspector Comment					
FS_ID:14327 DS_ID:22896 EP_NO: 2171 Repair Type: Non-Urgent Crossing Status: Indicator Found UCIP Comments: Appears abandoned as well off LS toe has been removed. Need to remove from levee or mark as appropriate. FIELD_STRUCT_DESC: 2 of 2: 3-inch pipe through levee 2.0 feet below crown (Permit No. 2171, 1958). Abandoned gas-pump station 260-feet off LS toe. FS Date: 5/29/2013

Gasline markers near where removed pumping plant was located.

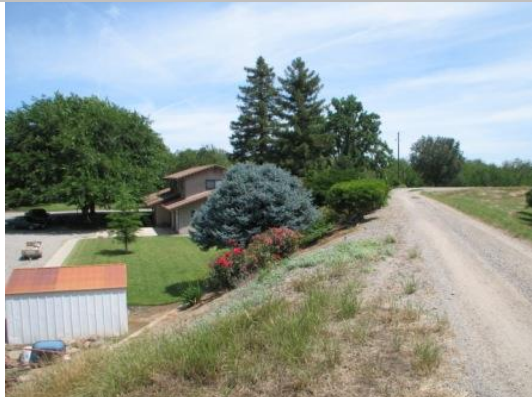
Photo 1 of 1 : FA_2016_LD0001G_432_6_20160823_00003.jpg

View of the permitted landscape on the landside slope of the levee.

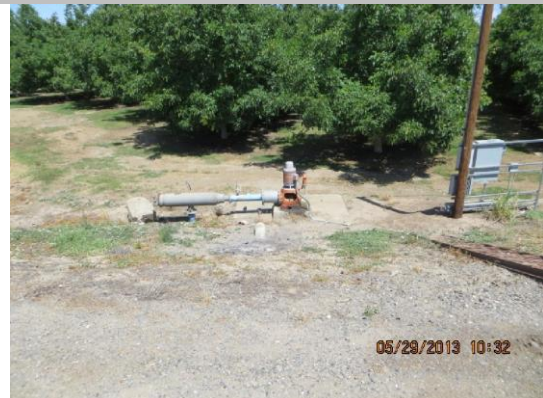
Photo 1 of 2 : UCIP_FA_2016_14331_23579.jpg

LM Start	2.22	Rating **	M	Issue No.	407
LM End	2.22	Issue Type +	En	Location *	LS
Category	Supplemental			GPS Latitude/Longitude	
				Start	End
Item	DWR UCIP Field Study			39.501690 °	39.501690 °
				-122.006100 °	-122.006100 °
DWR ID					
Comment Code					
Inspector Comment					
FS_ID:14331 DS_ID:22898 EP_NO: 5717A Repair Type: Non-Urgent Crossing Status: Found UCIP Comments: Pipe abandoned and should be done so properly. FIELD_STRUCT_DESC: 8-inch pipe sleeved through 12-inch though the levee 5-feet below the crown. Pump on landward side. Meter pole at landward toe, guy wire anchor in landward slope (Permit No. 5717A, 1969). FS Date: 5/29/2013

Pump at LS toe with no connection to 8-inch pipe.

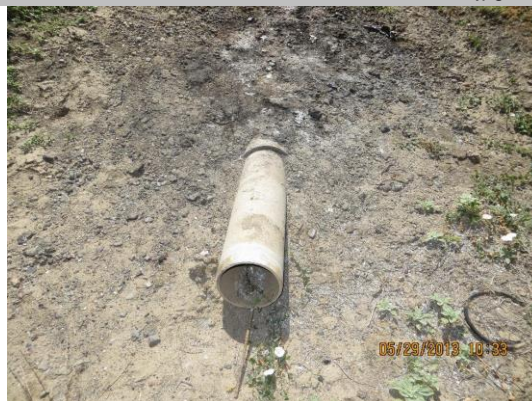
Photo 2 of 2 : UCIP_FA_2016_14331_23578.jpg

LM Start	2.22	Rating **	M	Issue No.	407 (cont)
LM End	2.22	Issue Type +	En	Location *	LS
Category	Supplemental			GPS Latitude/Longitude	
				Start	End
Item	DWR UCIP Field Study			39.501690 °	39.501690 °
				-122.006100 °	-122.006100 °
DWR ID					
Comment Code					
Inspector Comment					
FS_ID:14331 DS_ID:22898 EP_NO: 5717A Repair Type: Non-Urgent Crossing Status: Found UCIP Comments: Pipe abandoned and should be done so properly. FIELD_STRUCT_DESC: 8-inch pipe sleeved through 12-inch though the levee 5-feet below the crown. Pump on landward side. Meter pole at landward toe, guy wire anchor in landward slope (Permit No. 5717A, 1969). FS Date: 5/29/2013

8-inch pipe visible at LS toe.

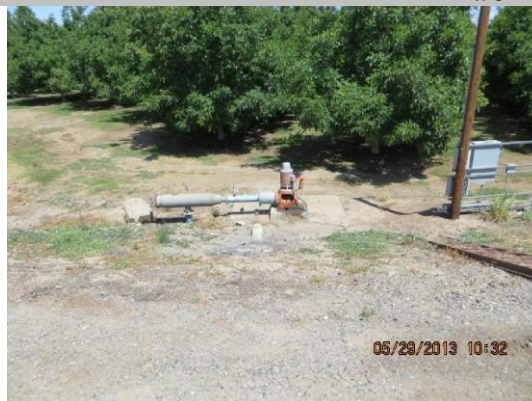
Photo 1 of 2 : UCIP_FA_2016_14332_23582.jpg

LM Start	2.22	Rating **	M	Issue No.	408
LM End	2.22	Issue Type +	En	Location *	LS
Category	Supplemental			GPS Latitude/Longitude	
				Start	End
Item	DWR UCIP Field Study			39.501690 °	39.501690 °
				-122.006099 °	-122.006099 °
DWR ID					
Comment Code					
Inspector Comment					
FS_ID:14332 DS_ID:22944 EP_NO: N/A Repair Type: Non-Urgent Crossing Status: Found UCIP Comments: Appears abandoned and should be done so properly. FIELD_STRUCT_DESC: *ABANDONED* 12-inch pipe through levee 5-feet below crown. Flap gate on W.S. 8-inch pipe sleeved through 12-inch. Open on LS. Originally included in the 1960 O&M manual. FS Date: 5/29/2013

Pump at location of pipe on LS toe.

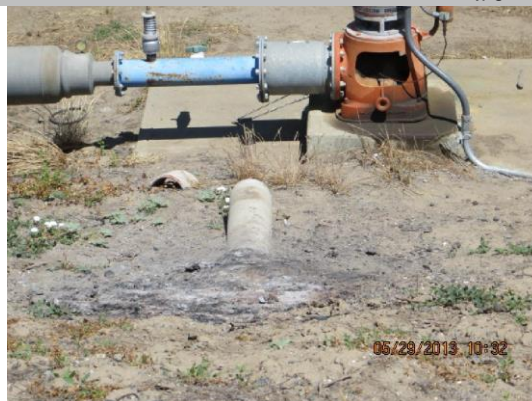
Photo 2 of 2 : UCIP_FA_2016_14332_23581.jpg

LM Start	2.22	Rating **	M	Issue No.	408 (cont)	
LM End	2.22	Issue Type +	En	Location *	LS	
Category	Supplemental			GPS Latitude/Longitude		
				Start	End	
Item	DWR UCIP Field Study			39.501690 °	39.501690 °	
				-122.006099 °	-122.006099 °	
DWR ID						
Comment Code						
Inspector Comment						
FS_ID:14332 DS_ID:22944 EP_NO: N/A Repair Type: Non-Urgent Crossing Status: Found UCIP Comments: Appears abandoned and should be done so properly. FIELD_STRUCT_DESC: *ABANDONED* 12-inch pipe through levee 5-feet below crown. Flap gate on W.S. 8-inch pipe sleeved through 12-inch. Open on LS. Originally included in the 1960 O&M manual. FS Date: 5/29/2013

Pipe next to pump at LS toe.

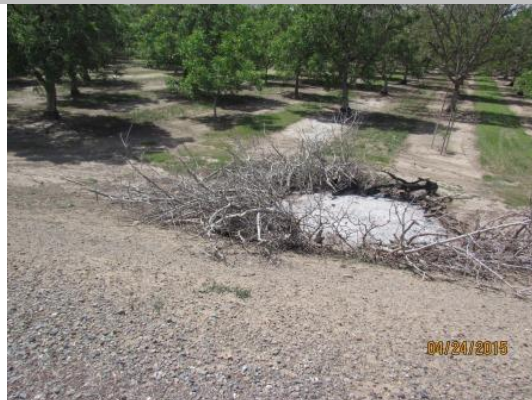
Photo 1 of 2 : FA_2016_LD0001G_432_61_20160823_00029.jpg

View of the prunings along the landside toe.

LM Start	2.48	Rating **	M	Issue No.	61
LM End	2.48	Issue Type +	En	Location *	LS
Category	Earthen Levee			GPS Latitude/Longitude	
				Start	End
Item	Encroachments			39.505237 °	39.505237 °
				-122.006493 °	-122.006493 °
DWR ID	DWR_LD0001G_01_s_2015_61				
Comment Code					
PR : Prunings					
Inspector Comment					
Remove prunings from the LS toe.

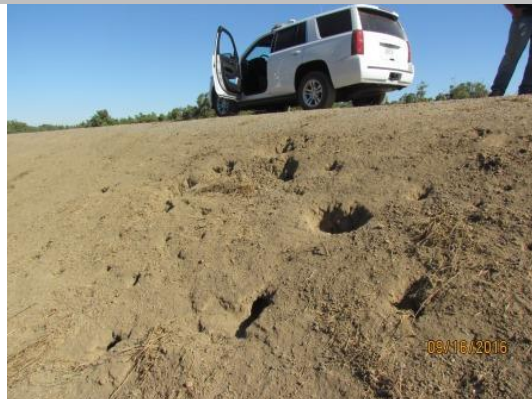
Photo 2 of 2 : FA_2016_LD0001G_432_51_20160922_00093.jpg

LM Start	3.09	Rating **	U	Issue No.	51 (cont)	
LM End	3.09	Issue Type +	Ma	Location *	LS	
Category	Earthen Levee			GPS Latitude/Longitude		
				Start		End
Item	Animal Control			39.513485 °		39.513485 °
				-122.009593 °		-122.009593 °
DWR ID	DWR_LD0001G_01_f_2014_51					
Comment Code						
A3 : No rodents visible, but rodent burrows visible; need to backfill and compact or grout burrows.						
Inspector Comment						
Repair the levee slope damaged by rodent activity.

View of the rodent holes along the landside slope.

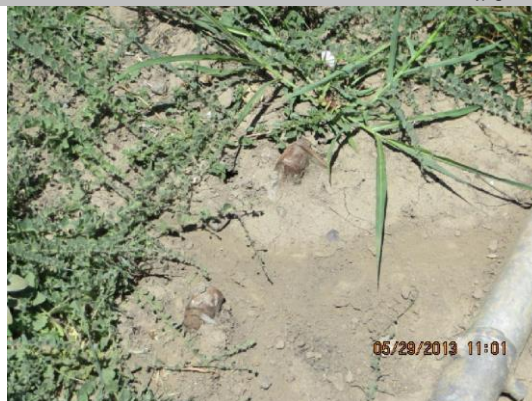
Photo 1 of 2 : UCIP_FA_2016_16223_27343.jpg

LM Start	3.13	Rating **	M	Issue No.	398
LM End	3.13	Issue Type +	En	Location *	LS
Category	Supplemental			GPS Latitude/Longitude	
				Start	End
Item	DWR UCIP Field Study			39.513835 °	39.513835 °
				-122.010029 °	-122.010029 °
DWR ID					
Comment Code					
Inspector Comment					
FS_ID:16223					
DS_ID:22901					
EP_NO: 9575					
Repair Type: Non-Urgent					
Crossing Status: Found					
UCIP Comments: Appears to have been abandoned. Need to verify pipe was grouted/abandoned properly.					
FIELD_STRUCT_DESC: *ABANDONED* 12-inch pipe through levee 14.0 feet below crown. Flap Gate on waterward end (ABO No. 9575, 1974).					
FS Date: 5/29/2013

Flap gate visible at WS toe.

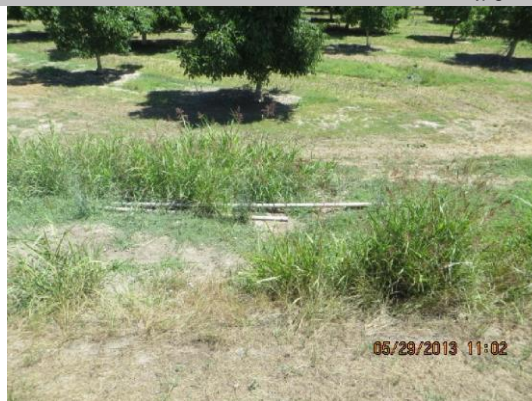
Photo 2 of 2 : UCIP_FA_2016_16223_27342.jpg

LM Start	3.13	Rating **	M	Issue No.	398 (cont)	
LM End	3.13	Issue Type +	En	Location *	LS	
Category	Supplemental			GPS Latitude/Longitude		
				Start	End	
Item	DWR UCIP Field Study			39.513835 °	39.513835 °	
				-122.010029 °	-122.010029 °	
DWR ID						
Comment Code						
Inspector Comment						
FS_ID:16223 DS_ID:22901 EP_NO: 9575 Repair Type: Non-Urgent Crossing Status: Found UCIP Comments: Appears to have been abandoned. Need to verify pipe was grouted/abandoned properly. FIELD_STRUCT_DESC: *ABANDONED* 12-inch pipe through levee 14.0 feet below crown. Flap Gate on waterward end (ABO No. 9575, 1974). FS Date: 5/29/2013

Flap gate visible at WS toe.

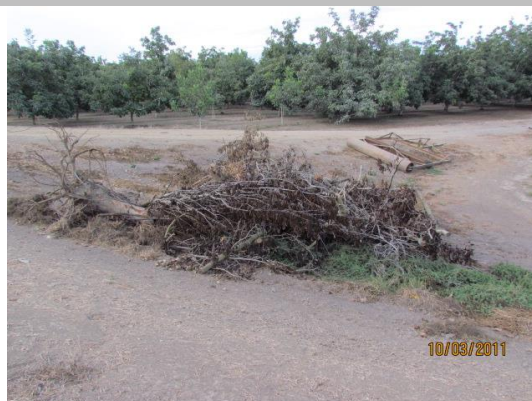
Photo 1 of 1 : FA_2016_LD0001G_432_16_20160823_00008.jpg

View of the pruning pile along the L/S toe.

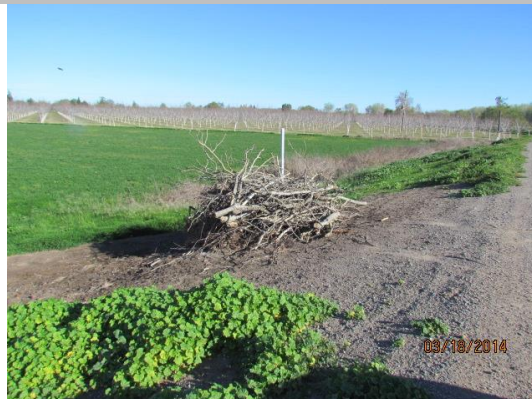
Photo 1 of 1 : FA_2016_LD0001G_432_46_20160823_00015.jpg

View of the prunings along the landside slope.

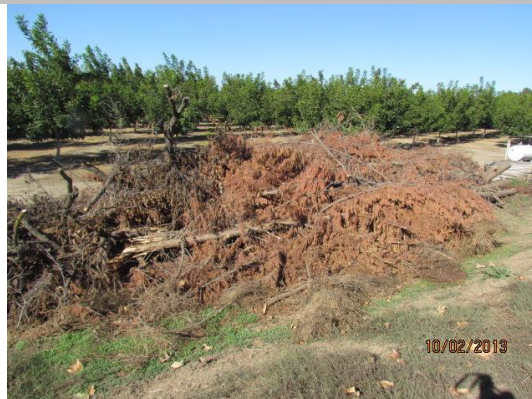
Photo 1 of 1 : FA_2016_LD0001G_432_56_20160823_00024.jpg

View of the prunings and limbs along the slope of the levee.

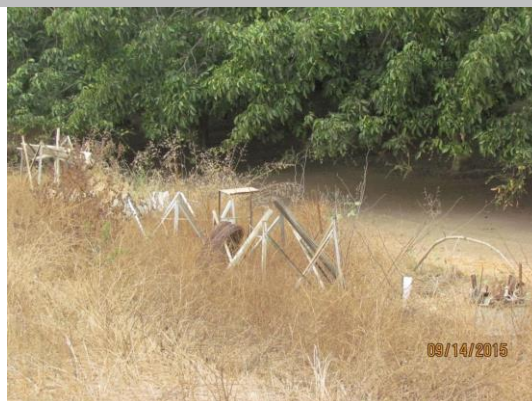
Photo 1 of 1 : FA_2016_LD0001G_432_23_20160823_00010.jpg

View of the equipment along the landside toe.

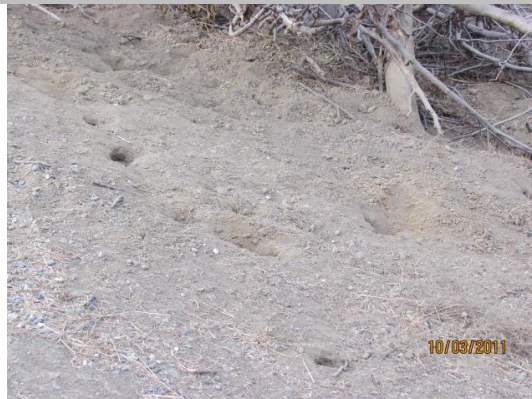
Photo 1 of 1 : FA_2016_LD0001G_432_395_20160823_00037.jpg

View of the rodent holes along the L/S toe.

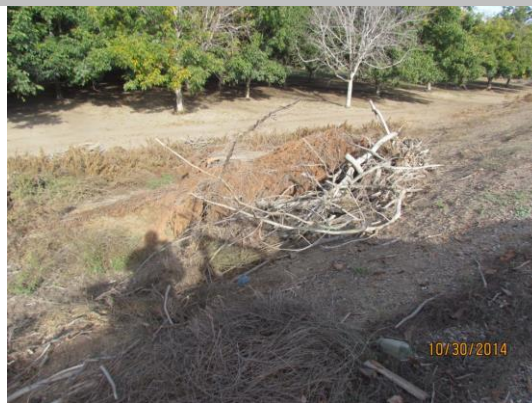
Photo 1 of 1 : FA_2016_LD0001G_432_52_20160823_00021.jpg

View of the prunings along the landside toe.

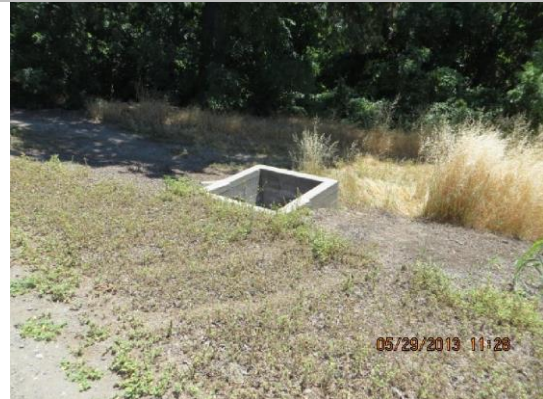
Photo 1 of 2 : UCIP_FA_2016_16243_27386.jpg

LM Start	3.98	Rating **	U	Issue No.	416
LM End	3.98	Issue Type +	En	Location *	LS
Category	Supplemental			GPS Latitude/Longitude	
				Start	End
Item	DWR UCIP Field Study			39.524990 °	39.524990 °
				-122.009575 °	-122.009575 °
DWR ID					
Comment Code					
Inspector Comment					
FS_ID:16243					
DS_ID:22904					
EP_NO: 9572					
Repair Type: Urgent					
Crossing Status: Found					
UCIP Comments: Broken flap gate and Concrete headwall on LS toe possibly tilting. Also a 3-inch alluminum irrigation line through the pipe.					
FIELD_STRUCT_DESC: 18-inch pipe through levee 7.3 feet below crown. Flap gate in 6'X6'concrete box on waterward end. Concrete bulkhead at landward toe (ABO No. 9572, 1974). Originally included in the 1960 O&M manual.					
FS Date: 5/29/2013

Distribution box on WS toe.

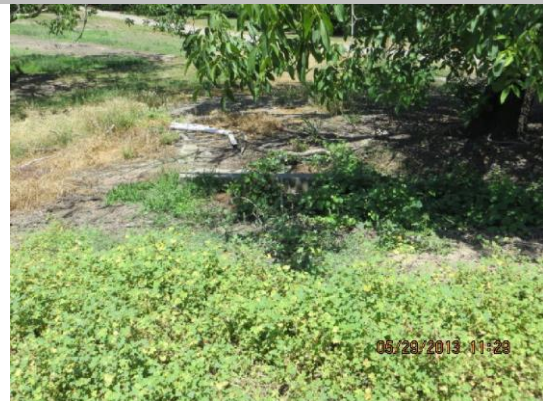
Photo 2 of 2 : UCIP_FA_2016_16243_27385.jpg

Headwall on LS toe.

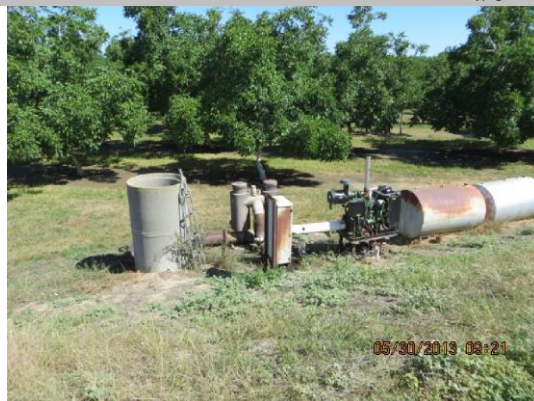
Photo 1 of 2 : UCIP_FA_2016_14343_23594.jpg

LM Start	4.25	Rating **	U	Issue No.	411
LM End	4.25	Issue Type +	En	Location *	LS
Category	Supplemental			GPS Latitude/Longitude	
				Start	End
Item	DWR UCIP Field Study			39.527050 °	39.527050 °
				-122.005247 °	-122.005247 °
DWR ID					
Comment Code					
Inspector Comment					
FS_ID:14343 DS_ID:22906 EP_NO: 1229 Repair Type: Urgent Crossing Status: Found UCIP Comments: Gate valve broken off in concrete standpipe on WS shoulder. 8-inch aluminum pipe sleeved through pipe prevents closure of 18-inch pipe. All concrete standpipes have been modified or broken. FIELD_STRUCT_DESC: 16-inch concrete irrigation pipe through the levee 8.6 feet below the crown. Gate valve in concrete well on waterward slope. Pump, service pole, engine, and fuel tank 48-inch standpipe at toe of landward slope (Permit No. 1229, 1947). Included in the 1960 O&M manual. FS Date: 5/30/2013

Pump, standpipe, and gate valve on LS toe.

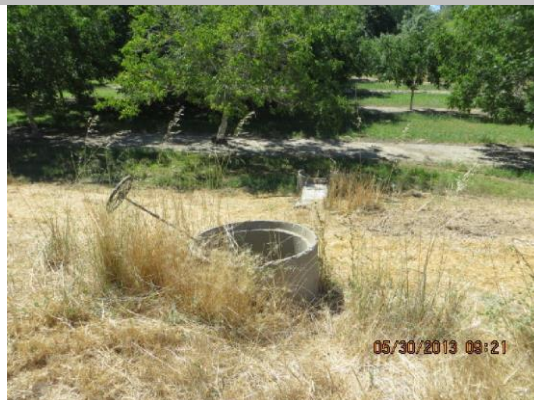
Photo 2 of 2 : UCIP_FA_2016_14343_23593.jpg

Gate valve in Concrete riser on WSs shoulder.

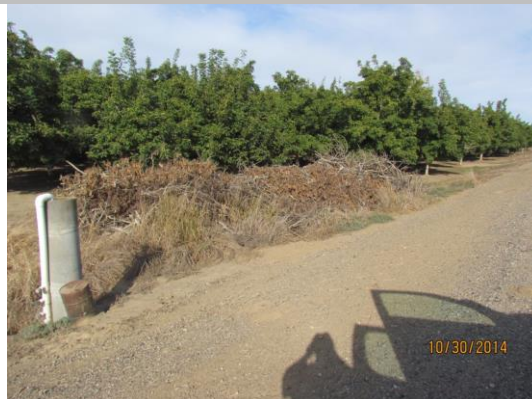
Photo 1 of 1 : FA_2016_LD0001G_432_54_20160823_00023.jpg

View of the prunings along the landside toe.

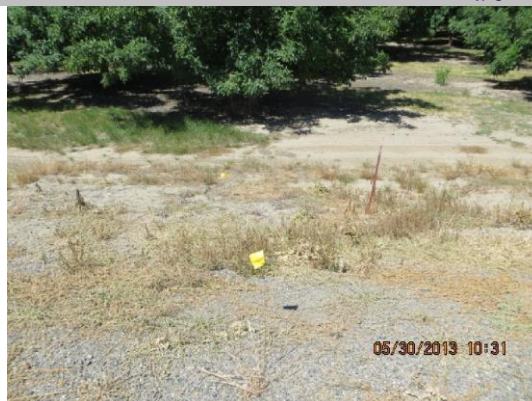
Photo 1 of 2 : UCIP_FA_2016_14352_23609.jpg

Gasline flags on LS slope.

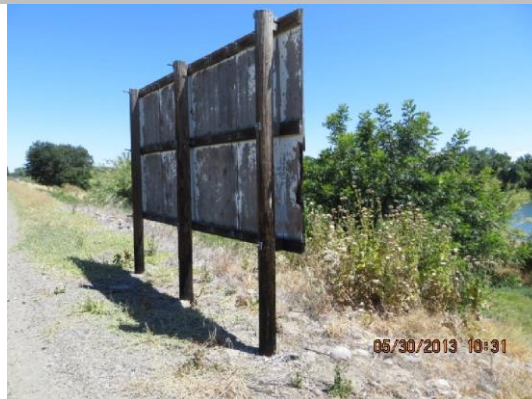
Photo 2 of 2 : UCIP_FA_2016_14352_23608.jpg

Gasline sign on WS shoulder.

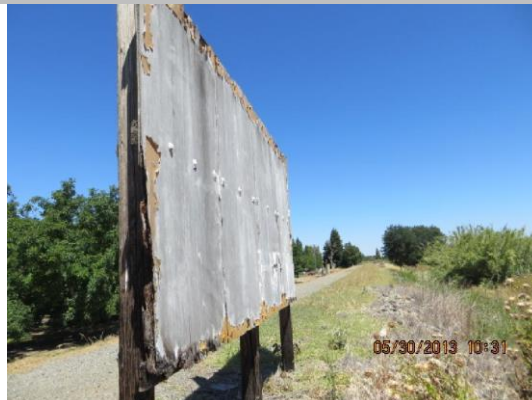
Photo 1 of 1 : UCIP_FA_2016_16224_27345.jpg

Gasline sign on WS shoulder.

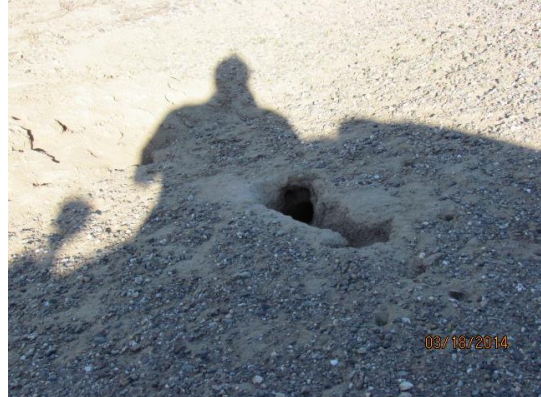
Photo 1 of 1 : FA_2016_LD0001G_432_47_20160823_00016.jpg

View of the rodent activity along the l/s slope.

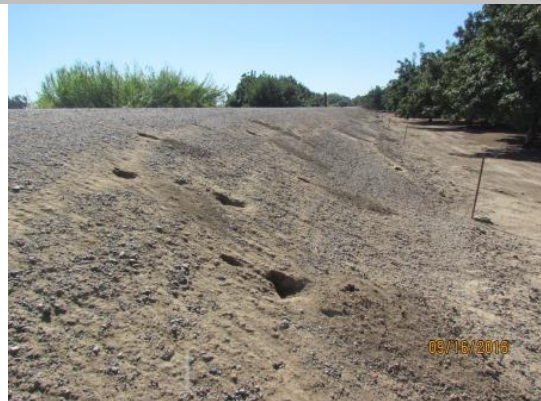
Photo 1 of 1 : FA_2016_LD0001G_432_76_20161003_00098.jpg

View of the rodent holes along the landside slope.

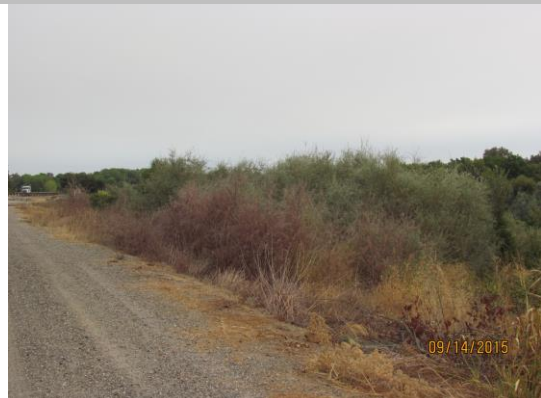
Photo 1 of 1 : FA_2016_LD0001G_432_65_20160823_00033.jpg

View of the vegetation along the waterside slope and toe.

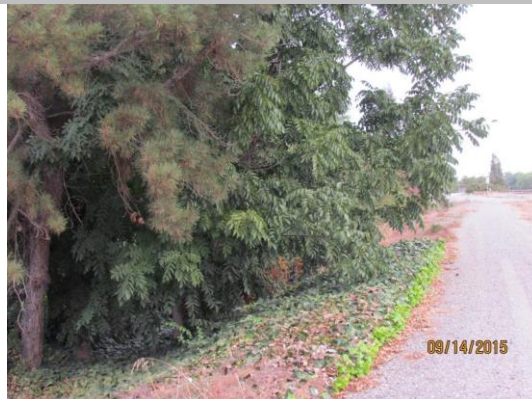
Photo 1 of 1 : FA_2016_LD0001G_432_64_20160823_00032.jpg

View of the trees along the landside toe.

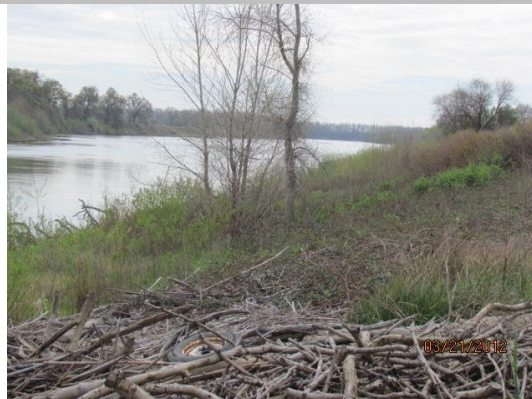
Photo 1 of 1 : FA_2016_LD0001G_432_10_20160823_00006.jpg

View of the Army Corps of Engineers mitigation site.

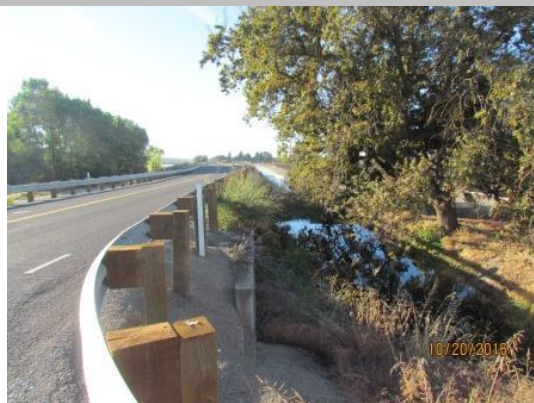
Photo 1 of 2 : FA_2016_LD0001G_432_69_20161028_00102.jpg

View of the ag ditch looking downstream.

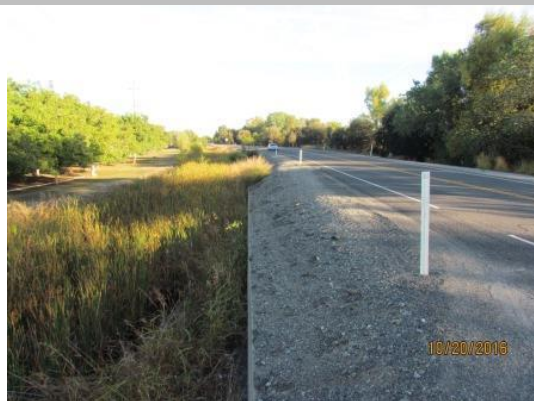
Photo 2 of 2 : FA_2016_LD0001G_432_69_20161028_00103.jpg

Another view of the ag ditch looking upstream.

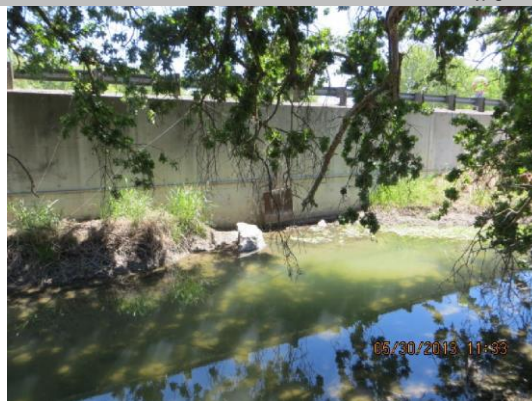
Photo 1 of 2 : UCIP_FA_2016_14373_23655.jpg

Pipe with steel plate welded over end on LS of levee crown.

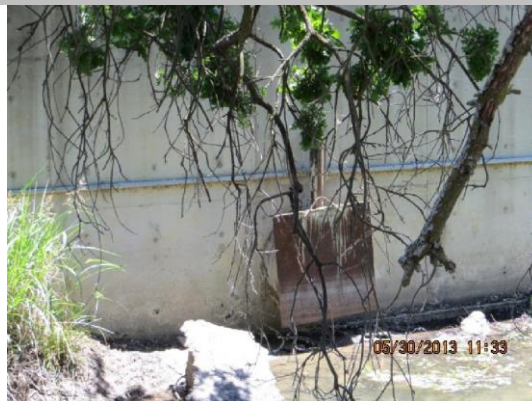
Photo 2 of 2 : UCIP_FA_2016_14373_23654.jpg

Pipe with steel plate welded over end on LS of levee crown.

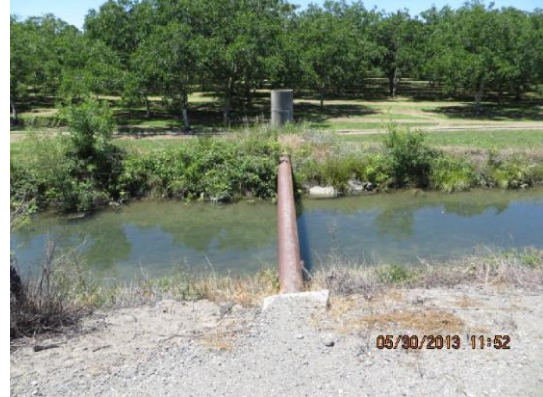
Photo 1 of 2 : UCIP_FA_2016_14384_23664.jpg

Pipe on LS toe with concrete standpipe visible.

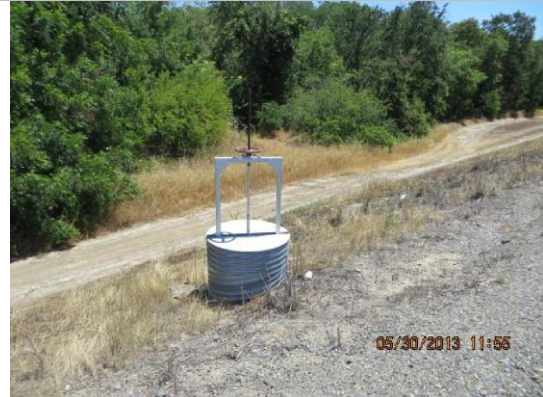
Photo 2 of 2 : UCIP_FA_2016_14384_23663.jpg

Slide gate in 36-inch CMP standpipe on WS slope

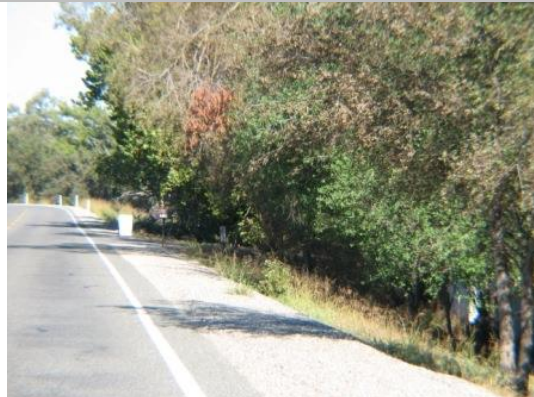
Photo 1 of 1 : FA_2016_LD0001G_432_20_20160823_00009.jpg

View of the trees and vegetation along the waterside slope of the levee.

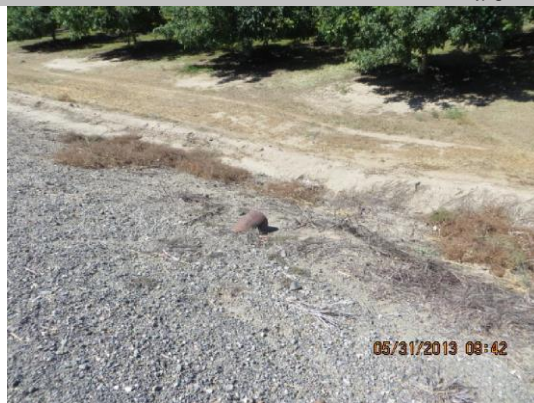
Photo 1 of 2 : UCIP_FA_2016_43096_23668.jpg

Pipe on LS slope.

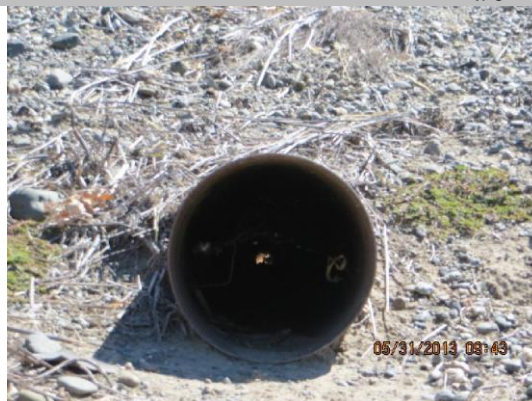
Photo 2 of 2 : UCIP_FA_2016_43096_23667.jpg

Pipe on LS slope.

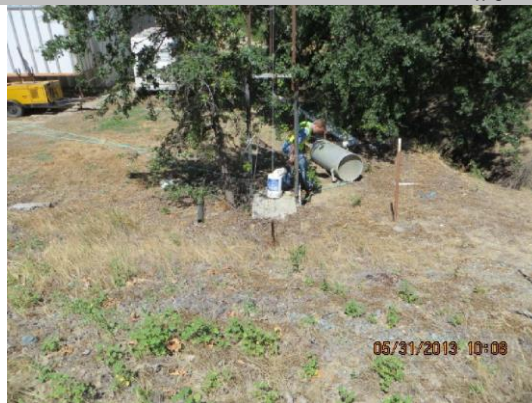
Photo 1 of 2 : UCIP_FA_2016_16204_27330.jpg

Pipe visible next to well with bucket over standpipe.

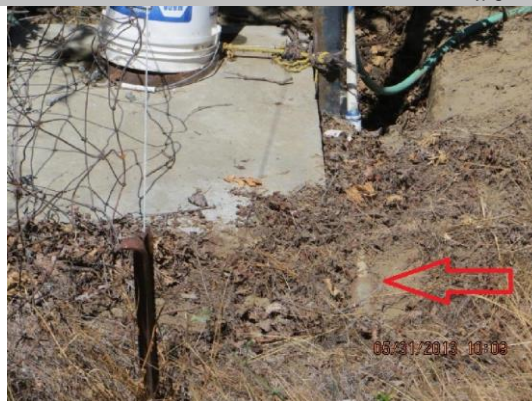
Photo 2 of 2 : UCIP_FA_2016_16204_27329.jpg

Pipe visible next to well with bucket over standpipe.

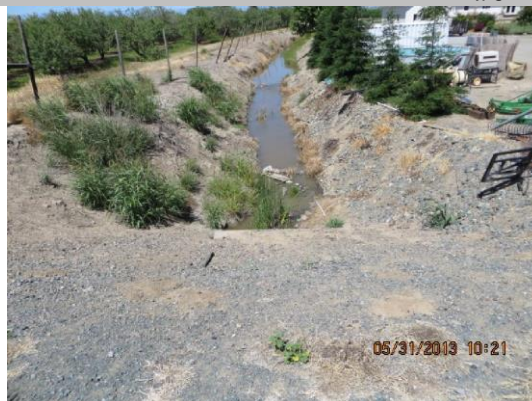
Photo 1 of 2 : UCIP_FA_2016_14389_23686.jpg

Pipe and headwall at LS toe.

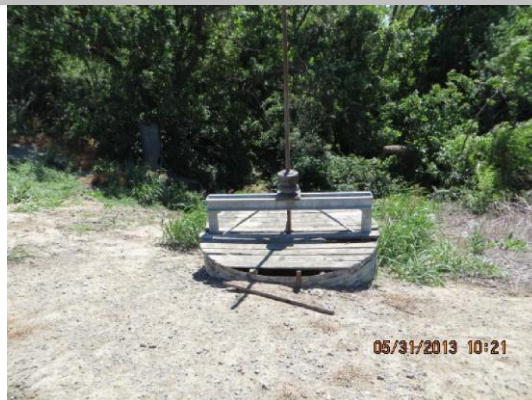
Photo 2 of 2 : UCIP_FA_2016_14389_23685.jpg

Slide gate in 8-foot diameter CMP riser on WS slope.

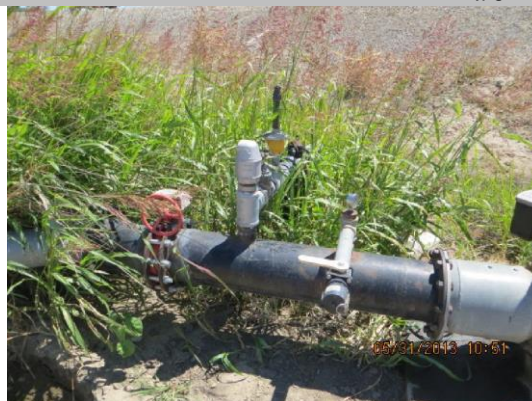
Photo 1 of 2 : UCIP_FA_2016_16205_27333.jpg

Pump with siphon breaker, vent and filter on LS toe.

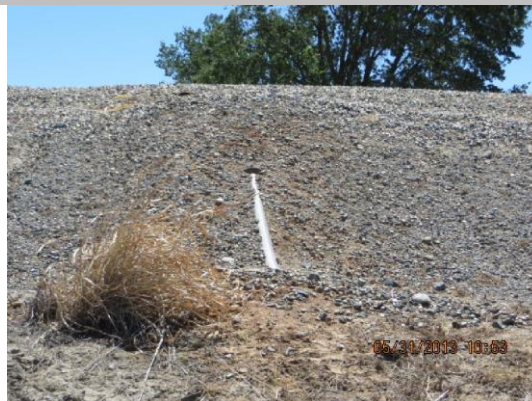
Photo 2 of 2 : UCIP_FA_2016_16205_27332.jpg

Pipe on LS slope.

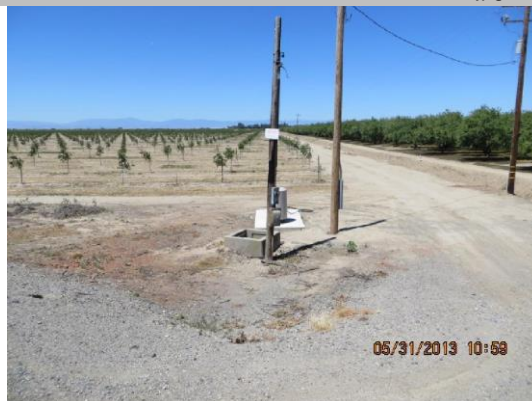
Photo 1 of 2 : UCIP_FA_2016_14561_23989.jpg

Concrete distribution box at LS toe.

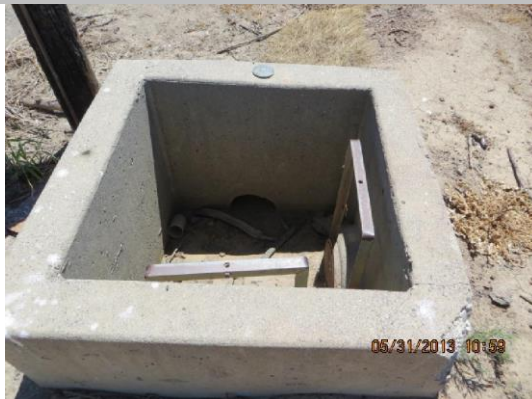
Photo 2 of 2 : UCIP_FA_2016_14561_23988.jpg

Concrete distribution box at LS toe with outlet from pipe through levee.

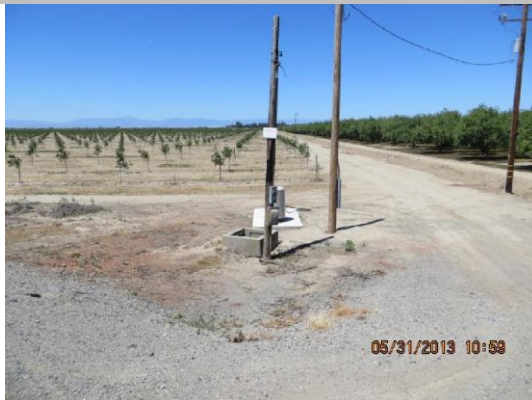
Photo 1 of 2 : UCIP_FA_2016_14562_23991.jpg

Source at JP next to concrete distribution box at LS toe.

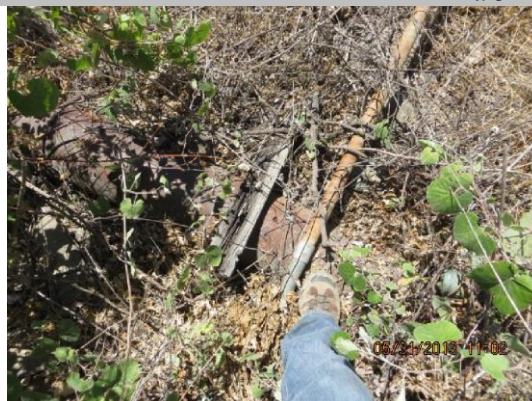
Photo 2 of 2 : UCIP_FA_2016_14562_23990.jpg

Pipe visible off WS toe.

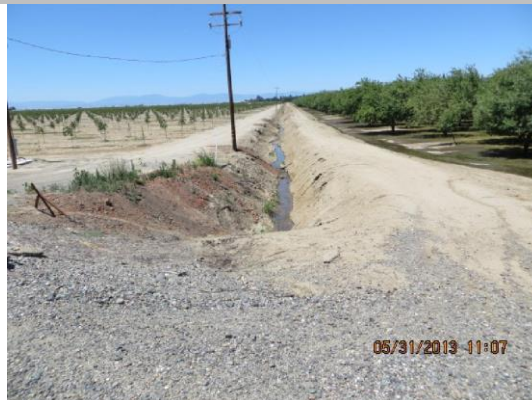
Photo 1 of 2 : UCIP_FA_2016_41784_24006.jpg

Drainage channel on LS toe.

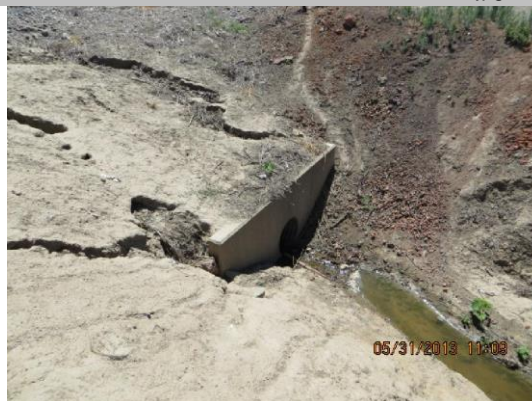
Photo 2 of 2 : UCIP_FA_2016_41784_24005.jpg

Concrete headwall and pipe at LS toe.

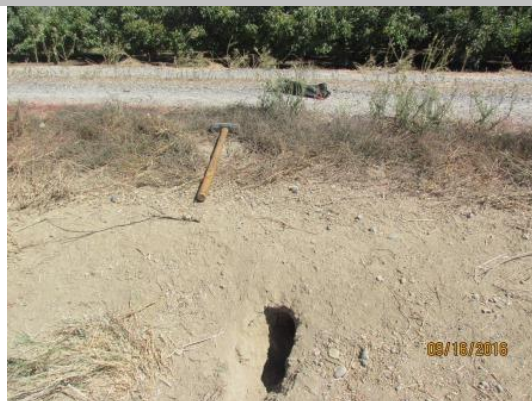
Photo 2 of 2 : FA_2016_LD0001G_432_79_20161003_00101.jpg

Another view of the rodent holes along the landside slope with a large hammer sitting next to the hole.

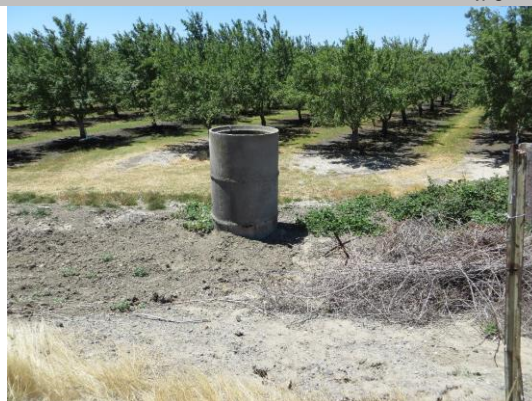
Photo 1 of 2 : UCIP_FA_2016_14567_24017.jpg

Concrete standpipe on LS toe.

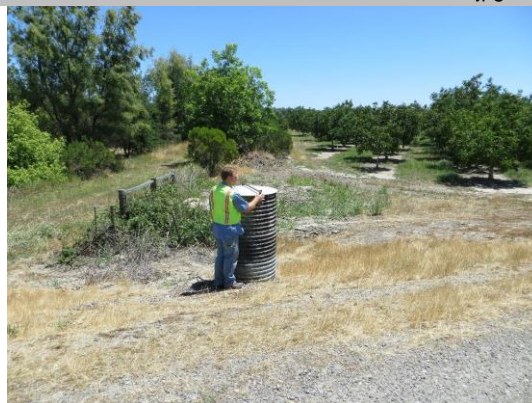
Photo 2 of 2 : UCIP_FA_2016_14567_24016.jpg

Slide gate in CMP riser on WS toe.

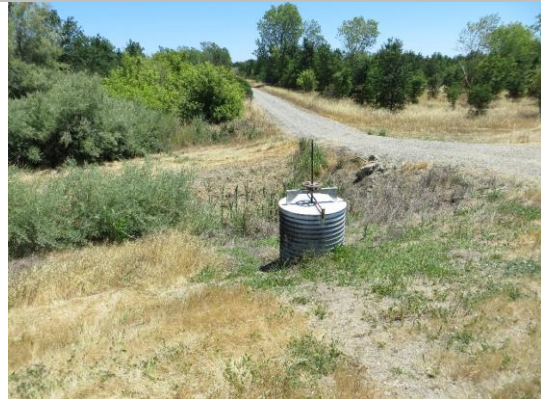
Photo 1 of 2 : UCIP_FA_2016_14569_24026.jpg

Slidegate in 36-inch CMP riser on WS slope.

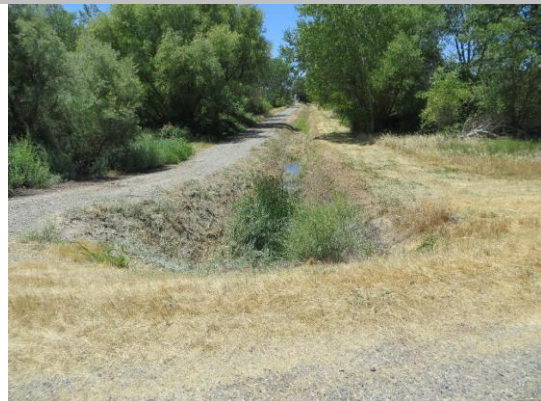
Photo 2 of 2 : UCIP_FA_2016_14569_24025.jpg

Drainage channel on LS toe.
